Manhole Inspection Summary

Manhole # S19AA2001MH

Location Address: **1611 ROGERS AVE**

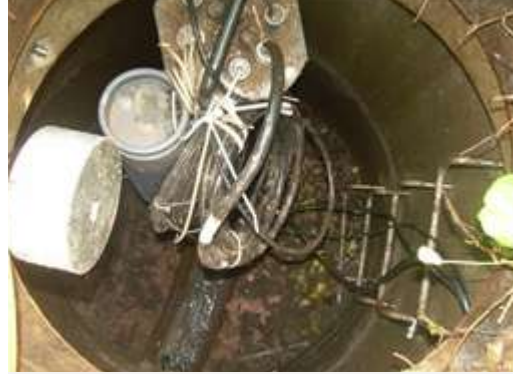
Top View

Evidence of surcharge - Bench debris.

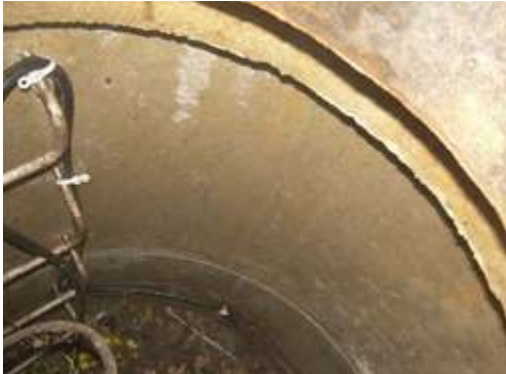
Defect

Frame leaks. Corbel and Barrel infiltration.

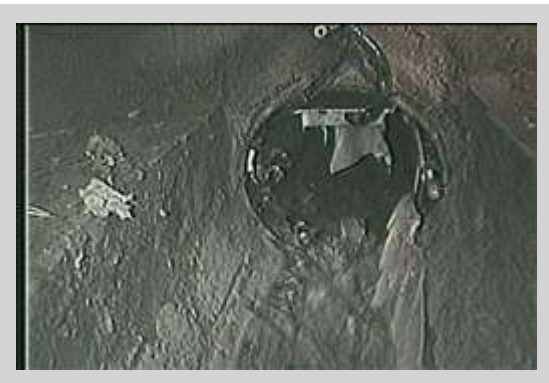
8 in. Circular Gravity Sewer Pipe In @ 7 O'Clock

Infiltration: **Evidence** Pipe Seal Cond: **Cracked**
